DEPARTMENT OF TRANSPORTATION

Contract #: 04-0120F4Cty: SF/ALA Rte: 80 PM: 13.2/13.9File #: 69.28**WELDING INSPECTION REPORT****Resident Engineer:** Pursell, Gary**Address:** 333 Burma Road**City:** Oakland, CA 94607**Report No:** WIR-020053**Date Inspected:** 24-Mar-2010**Project Name:** SAS Superstructure**OSM Arrival Time:** 700**Prime Contractor:** American Bridge/Fluor Enterprises, a JV**OSM Departure Time:** 1900**Contractor:** Zhenhua Port Machinery Company, Ltd (ZPMC), Changxing Island **Location:** Shanghai, China

CWI Name:	Liu Hua Jie, Lu Li Qing, Geng Wei			CWI Present:	Yes	No
Inspected CWI report:	Yes	No	N/A	Rod Oven in Use:	Yes	No N/A
Electrode to specification:	Yes	No	N/A	Weld Procedures Followed:	Yes	No N/A
Qualified Welders:	Yes	No	N/A	Verified Joint Fit-up:	Yes	No N/A
Approved Drawings:	Yes	No	N/A	Approved WPS:	Yes	No N/A
				Delayed / Cancelled:	Yes	No N/A
Bridge No:	34-0006			Component:	Orthotropic Box Girder (OBG)

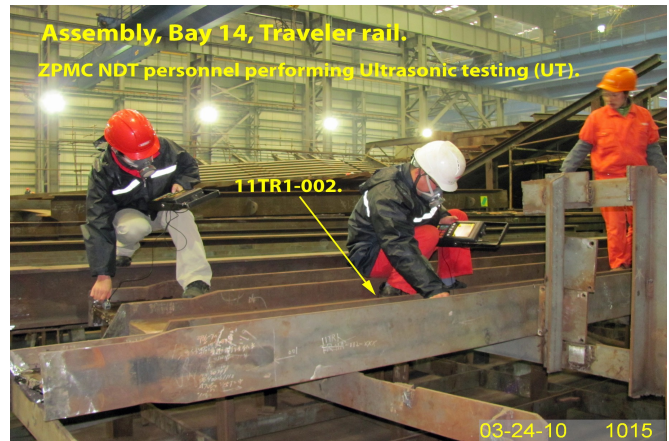
During Random Visual in process Inspection, this QA inspector observed ZPMC personnel performing Ultrasonic testing (UT) on Traveler rail identified as 11TR002-005. The attached photographs provide additional detail.

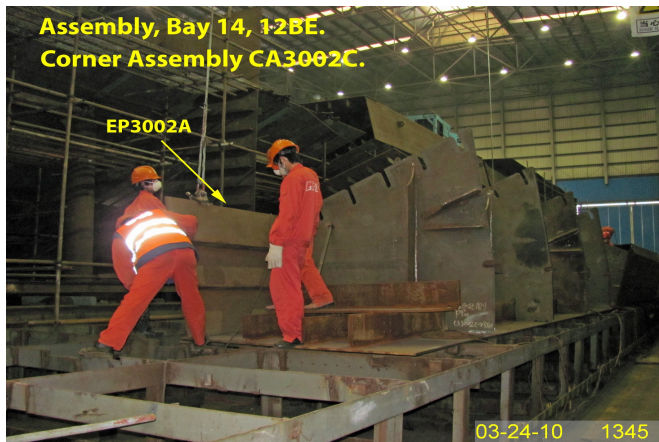
During the Quality Assurance (QA) random in-process visual inspection, this QA inspector ZPMC Personnel performing fit up of Edge plate identified as EP3002A. The attached photographs provide additional detail.
